Photo Log

Mark Ford Training Center

CWA Section 404 Inspection: September 22, 2016

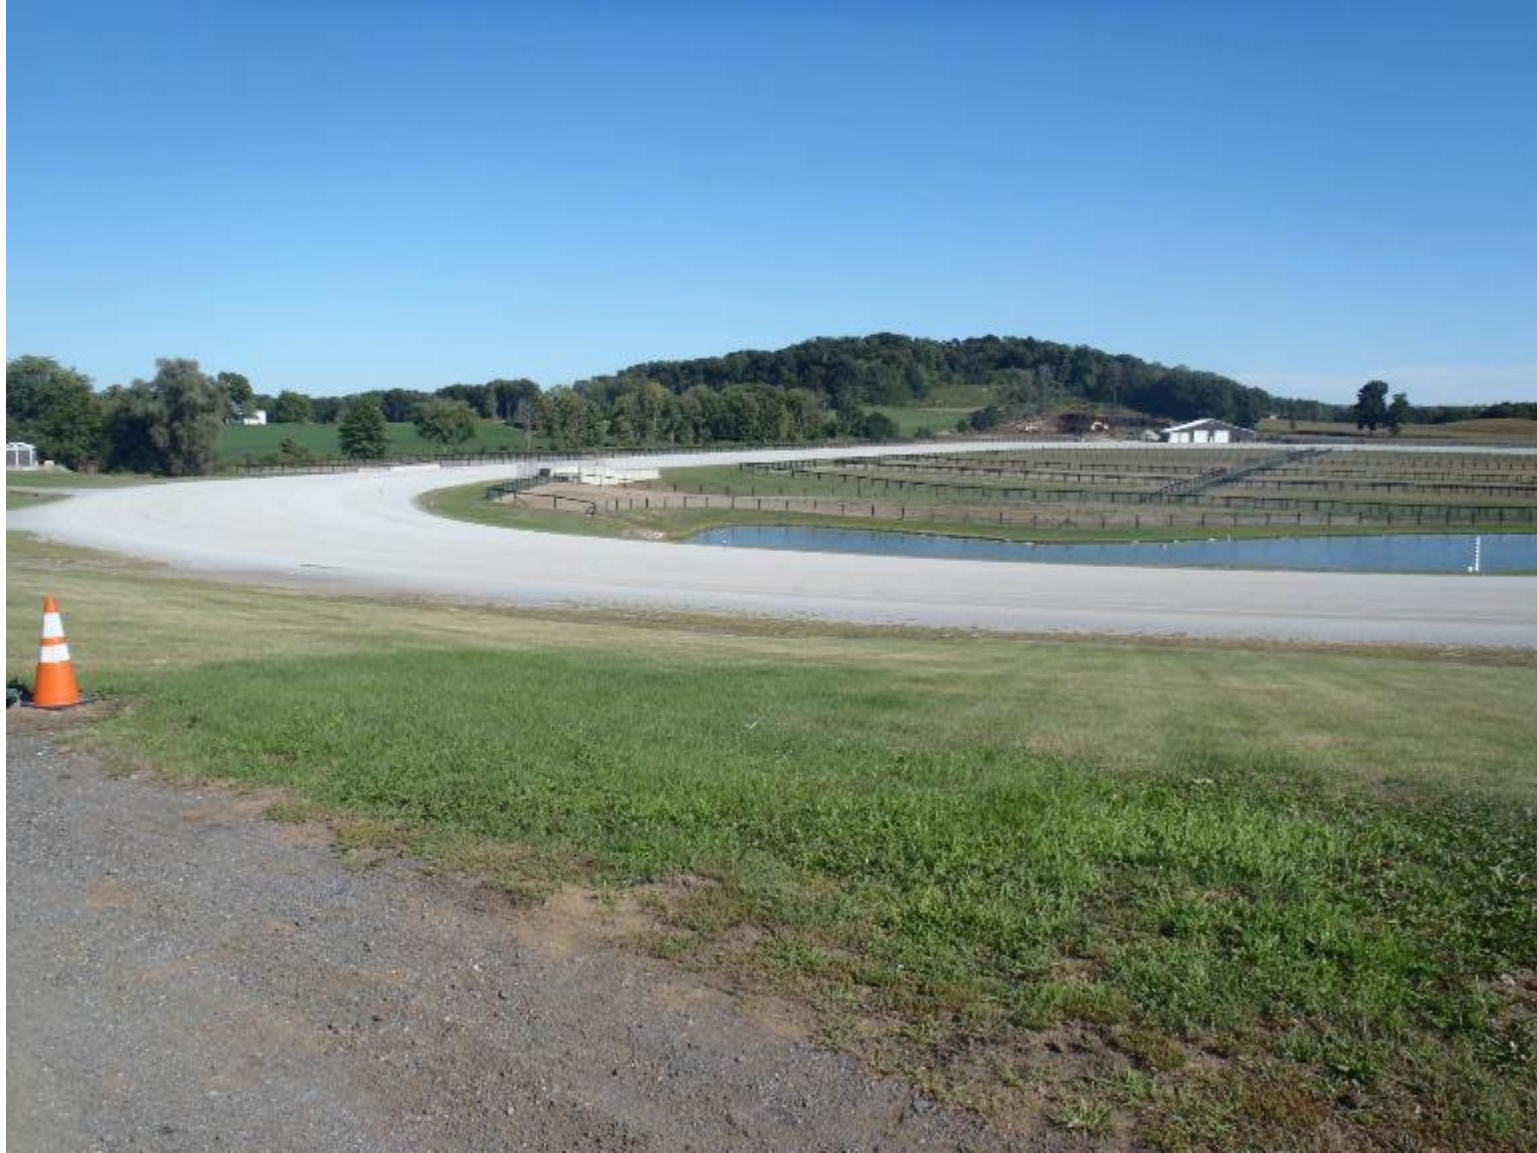
P9220029 – Overview of Site, Taken from Barn Area

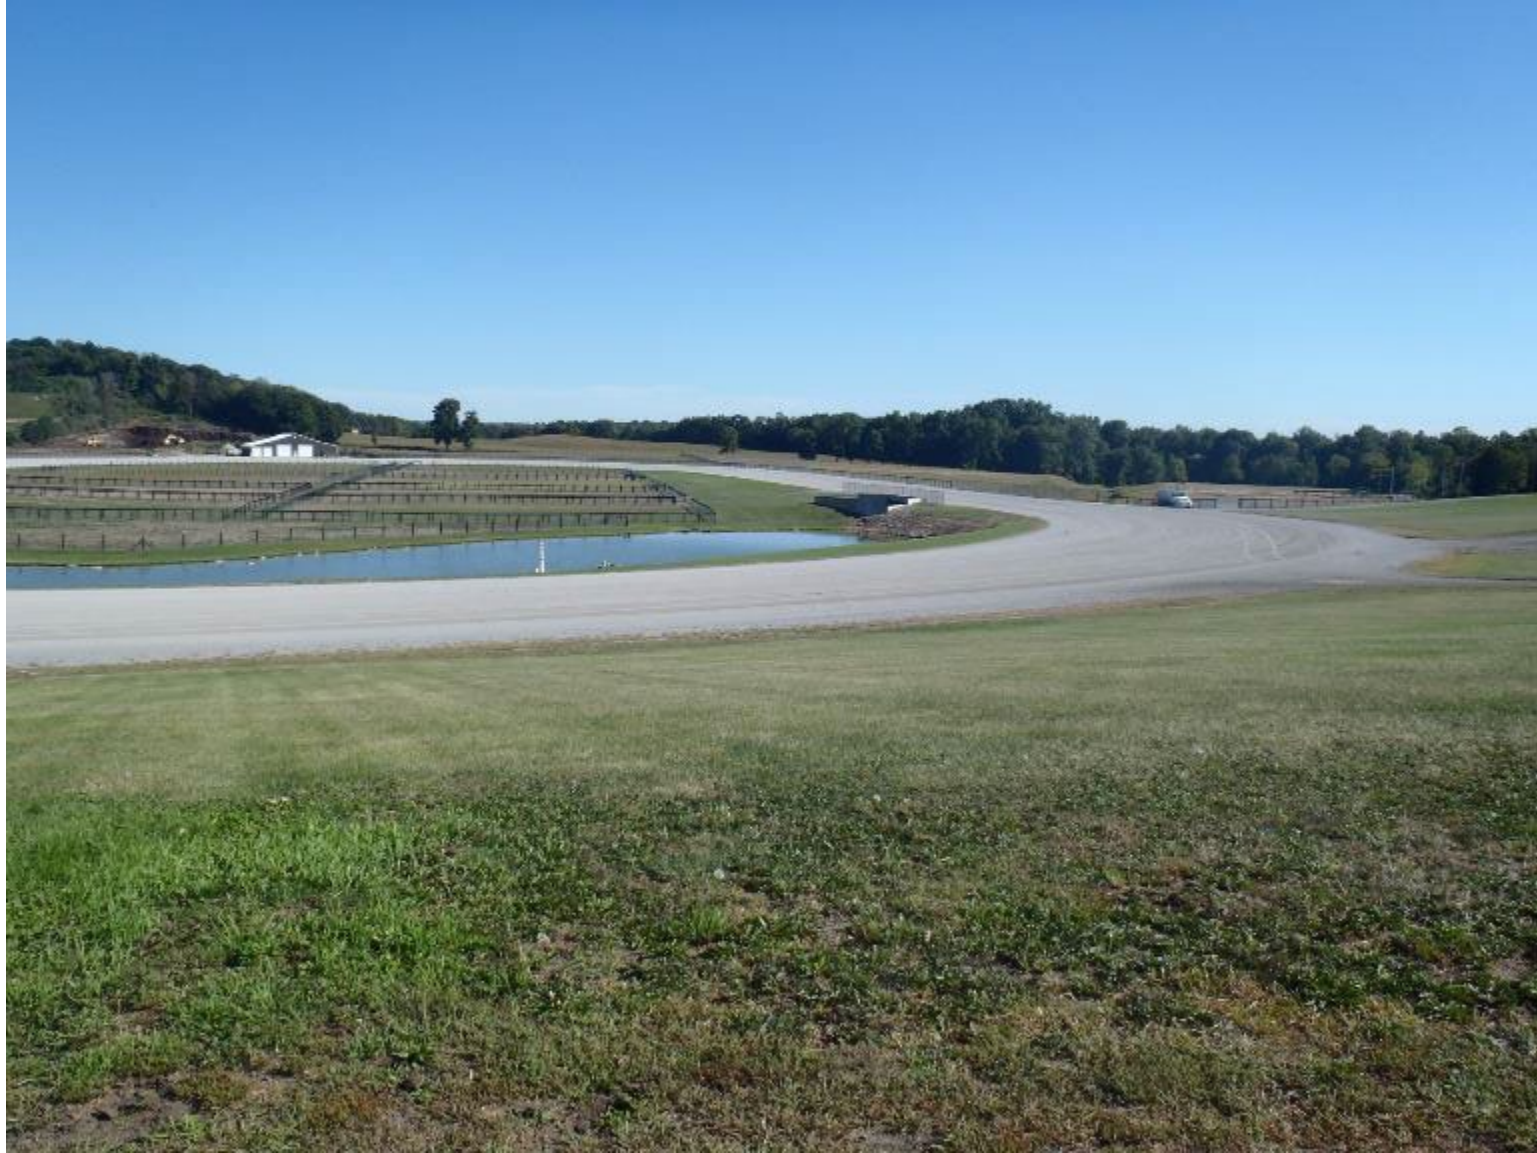
P9220030 – Overview of Site, Taken from Barn Area

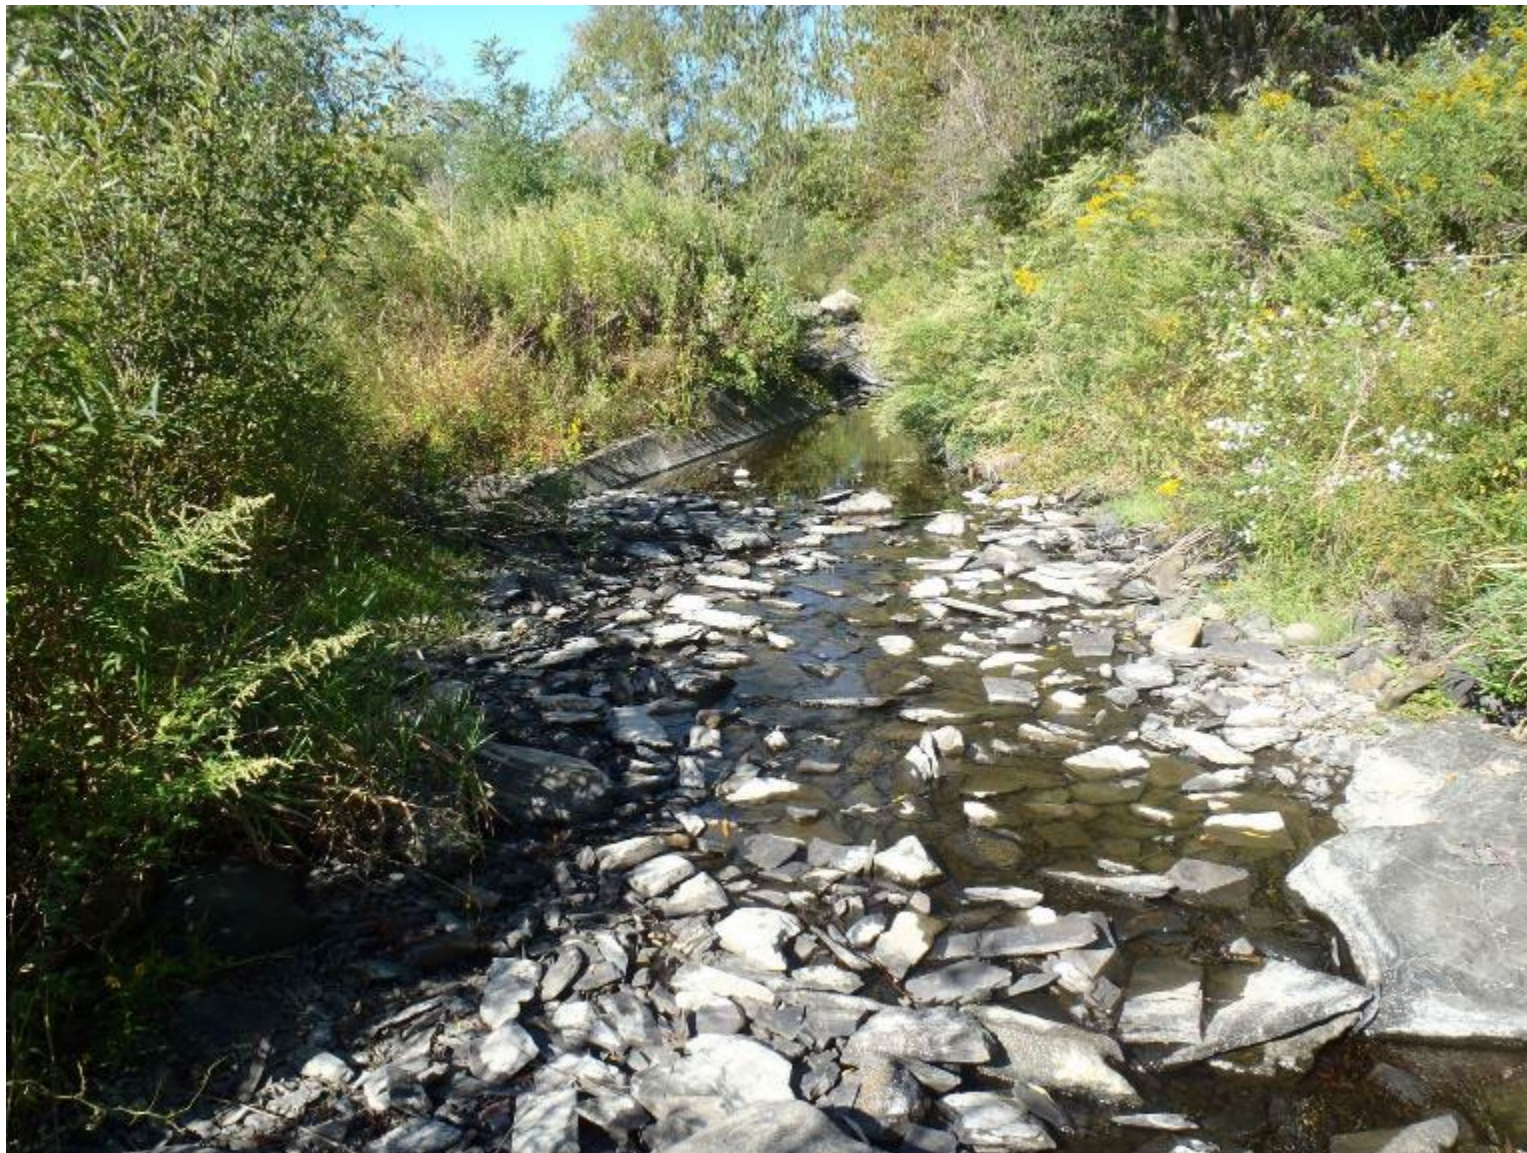
P9220031 – Looking Upstream from Property Edge

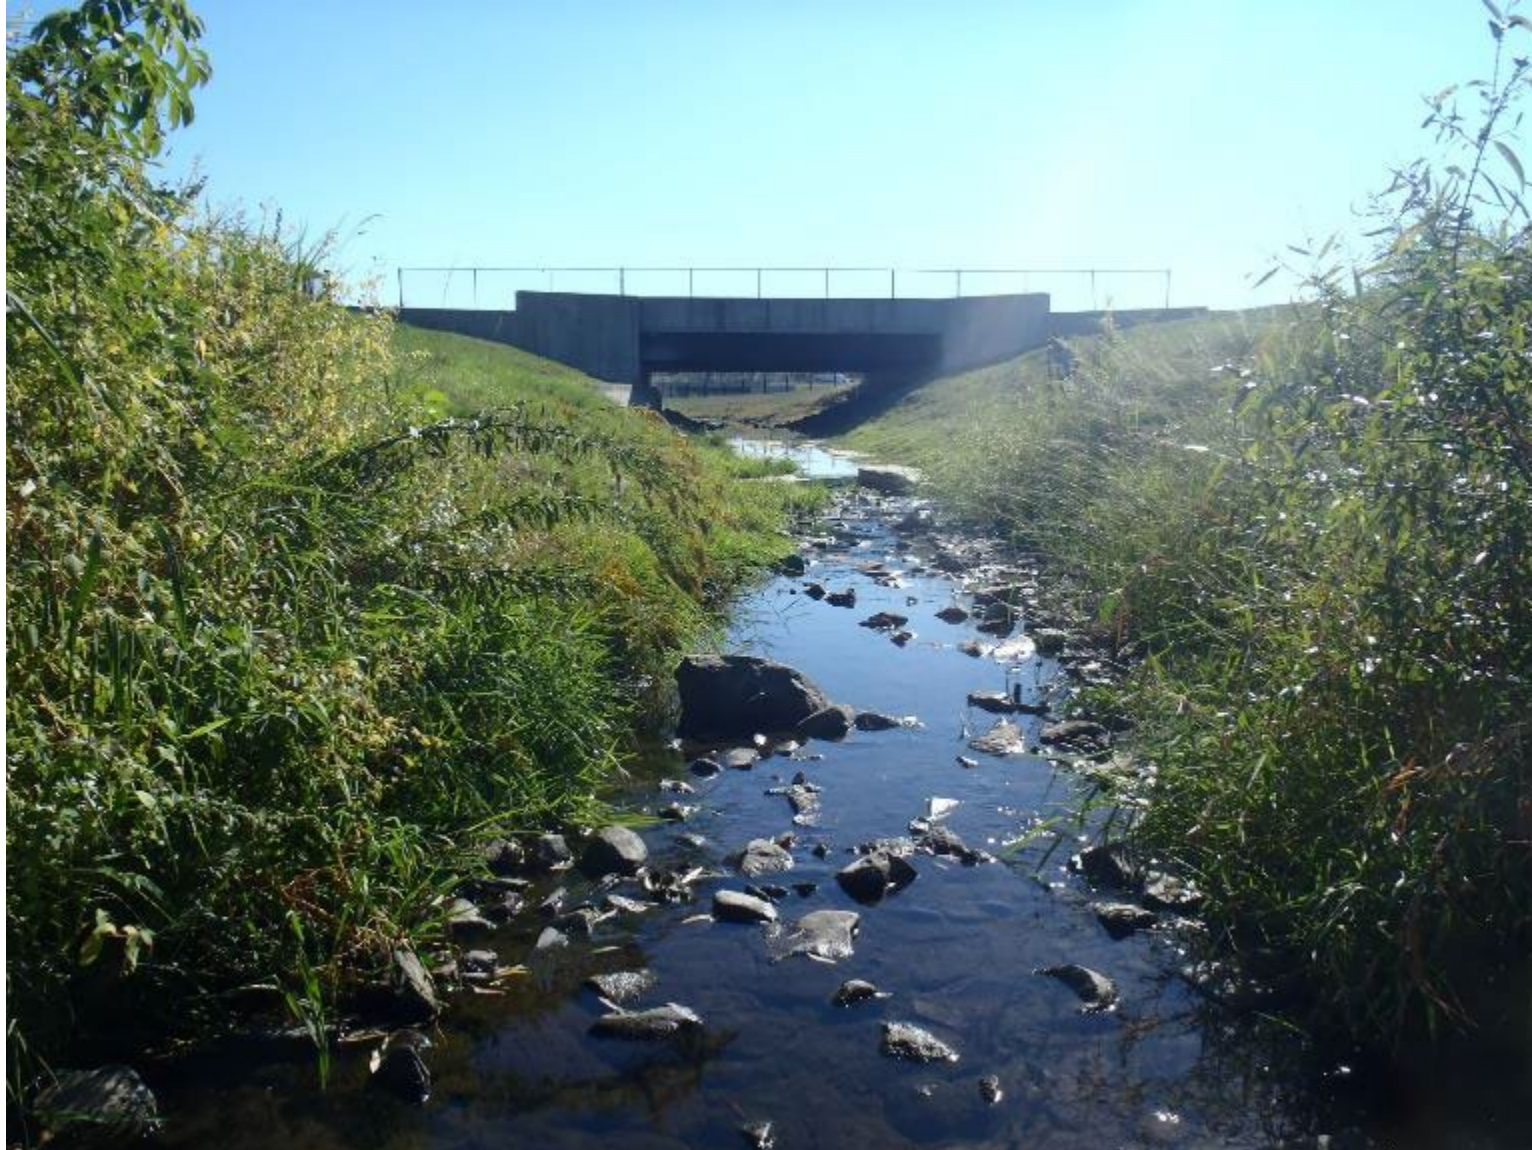
P9220032 – Looking Downstream from Property Edge

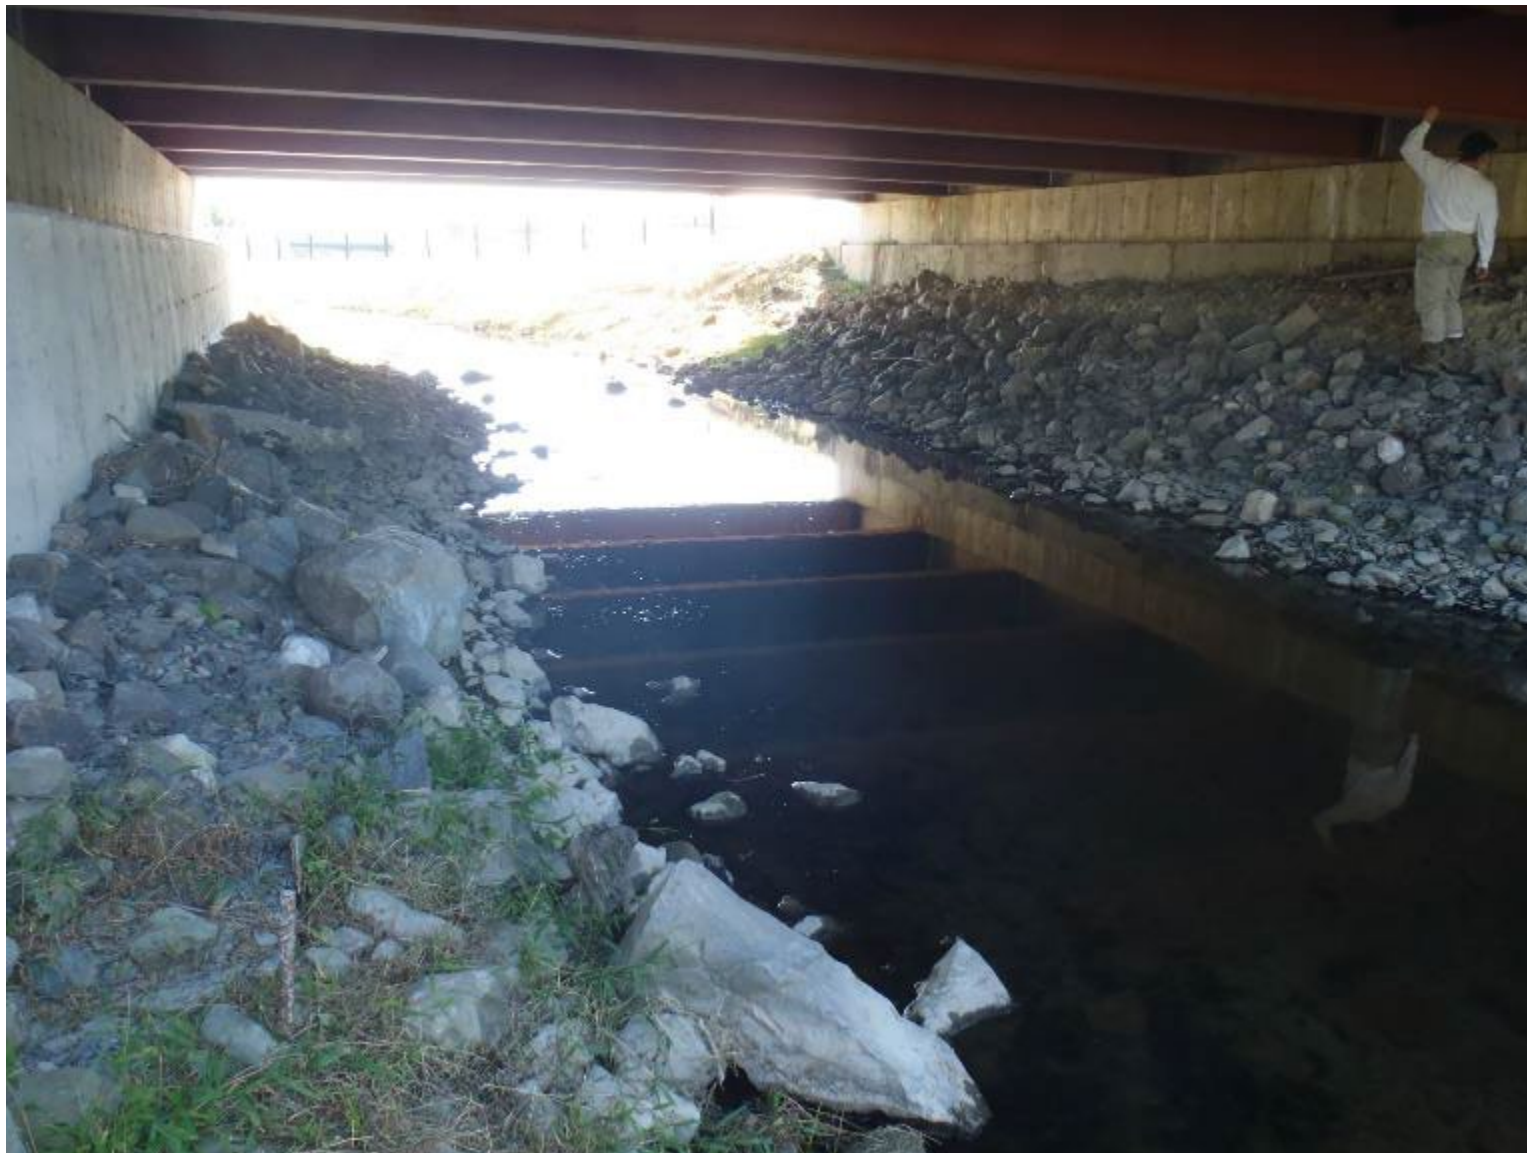
P9220033 – Under North Bridge, Looking Downstream

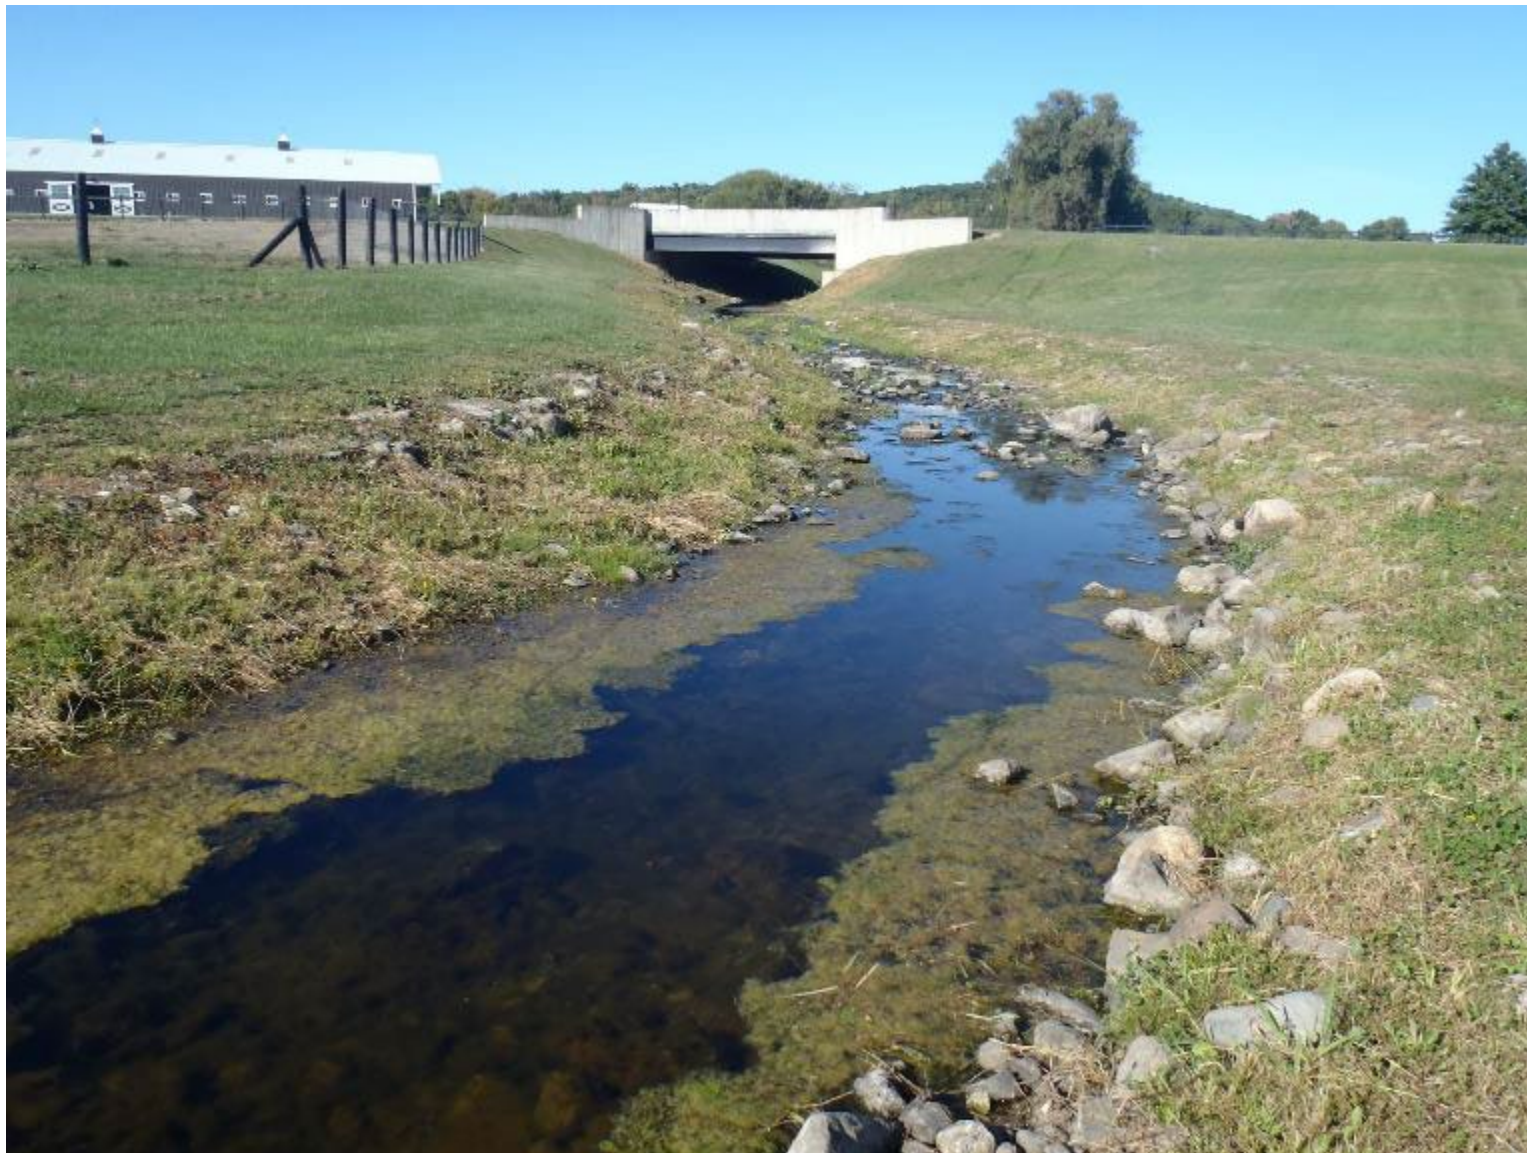
P9220034 – Inside of Track, Looking Downstream

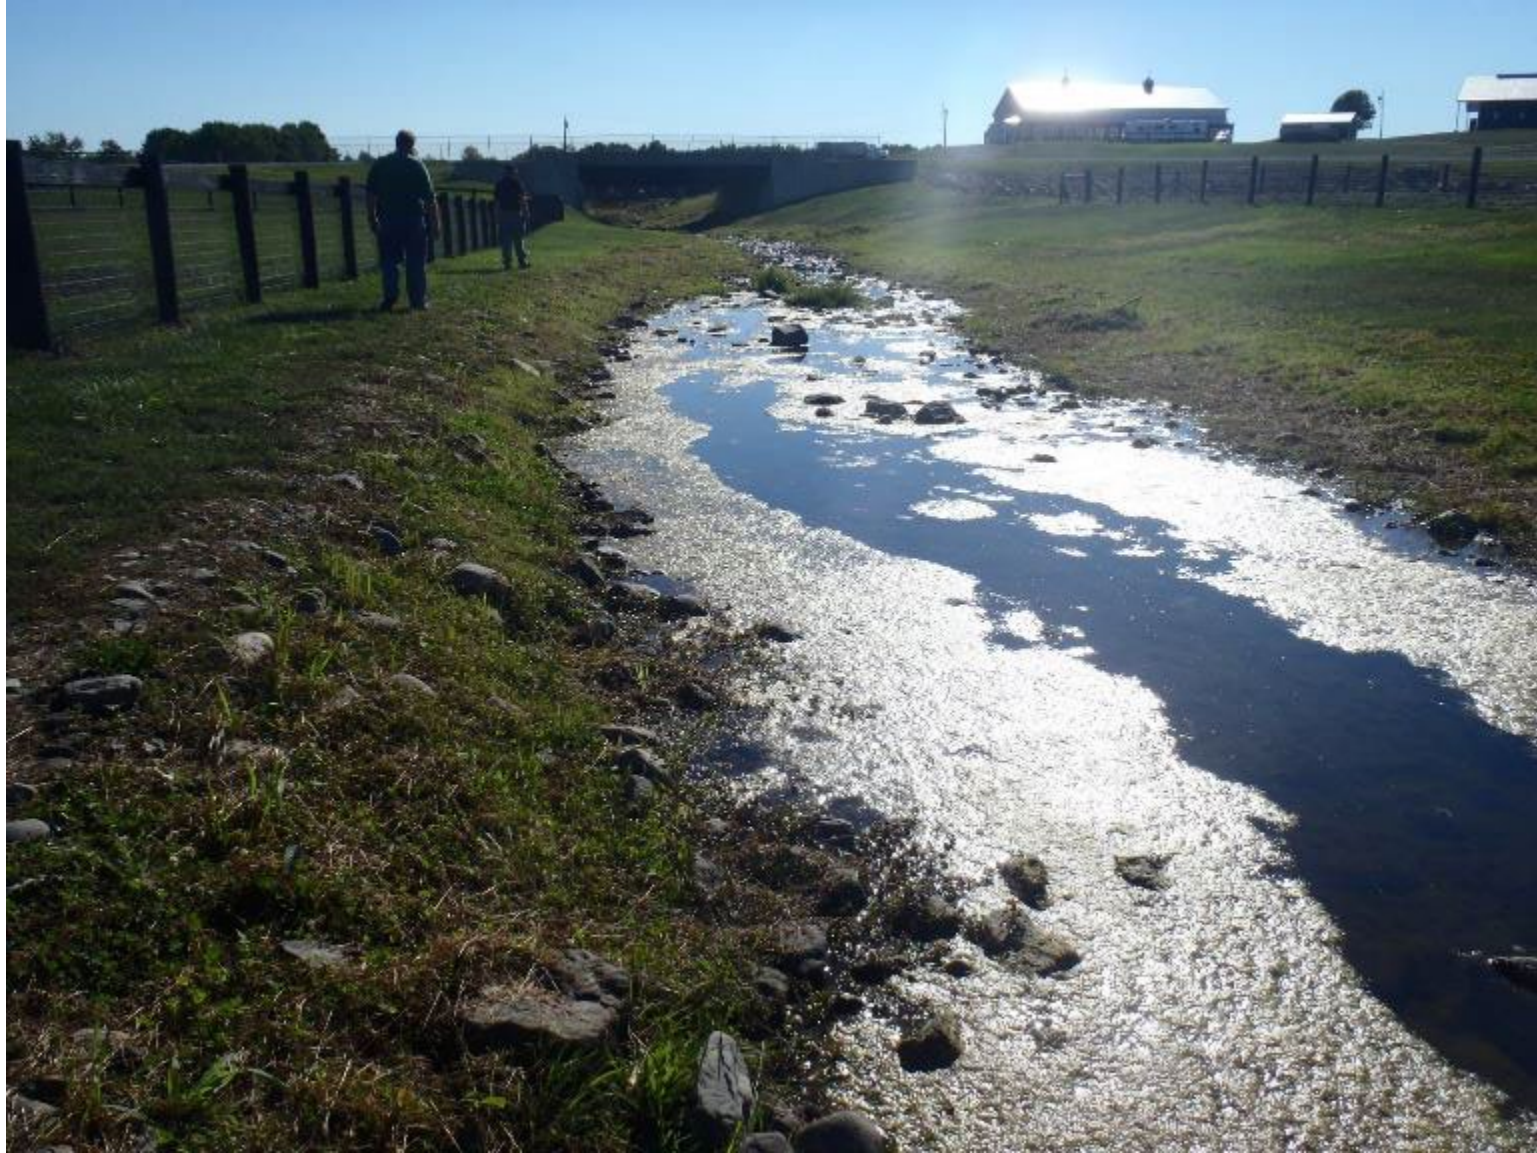
P9220035 – Inside of Track, Looking Upstream

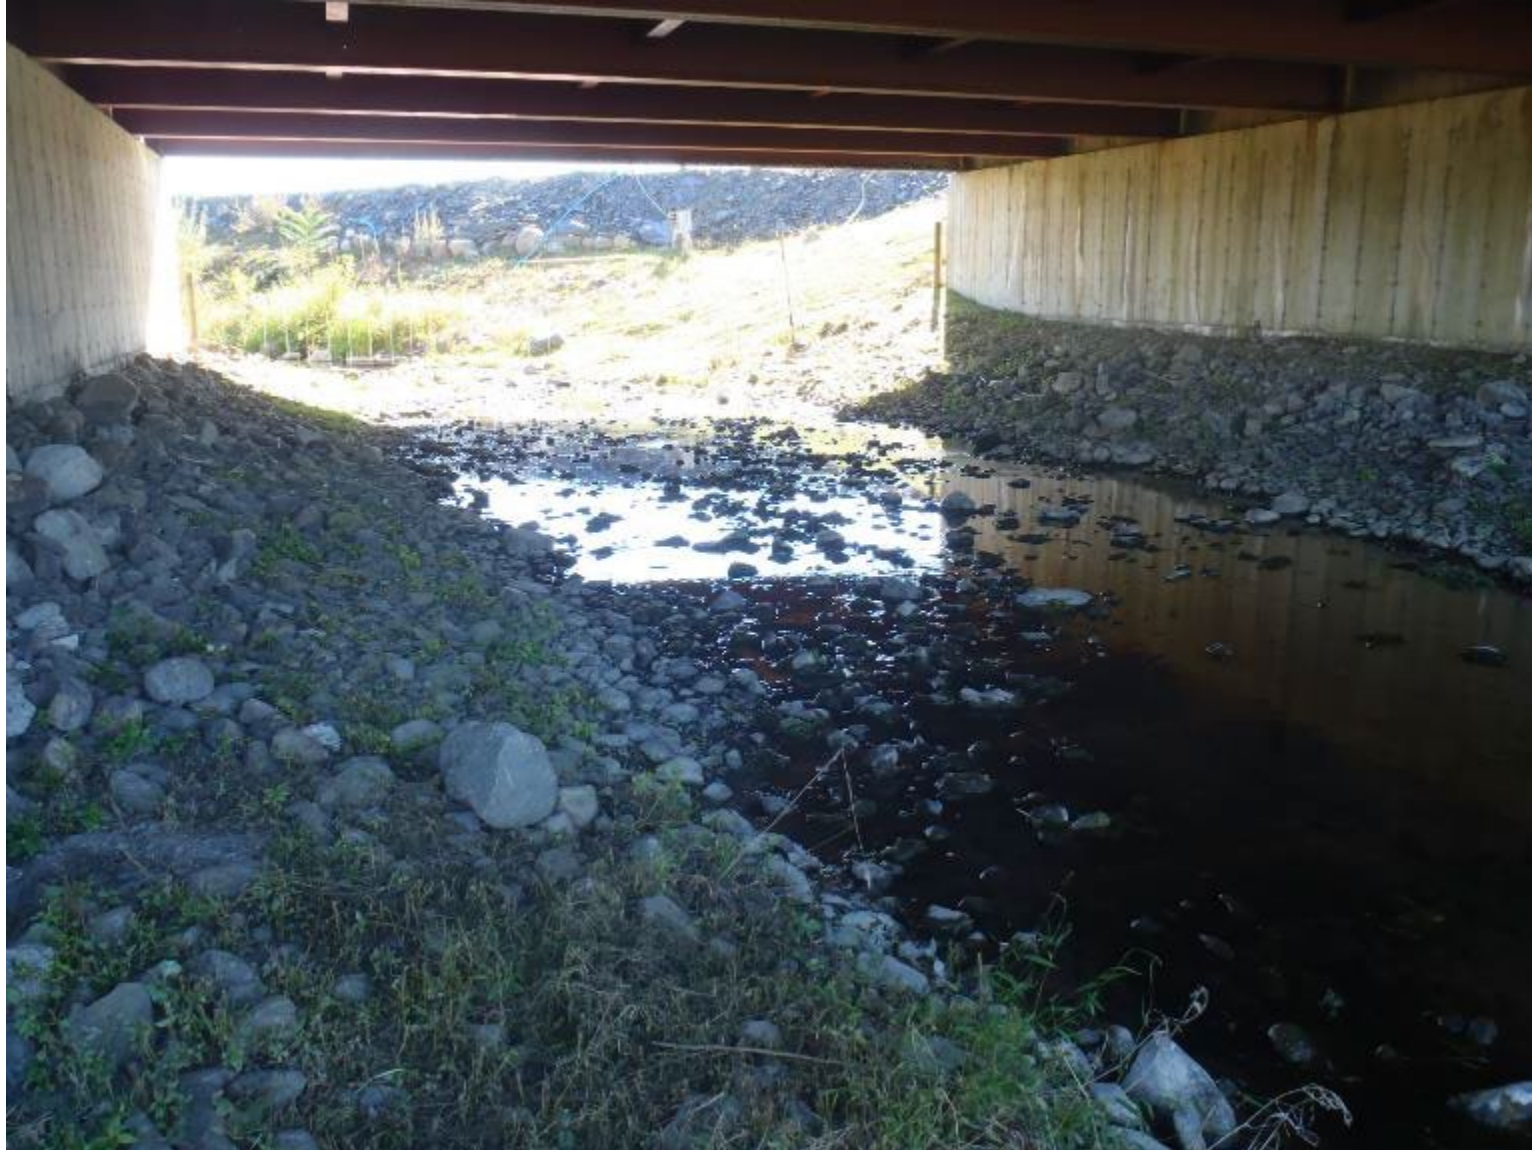
P9220036 – Under South Bridge, Looking Downstream

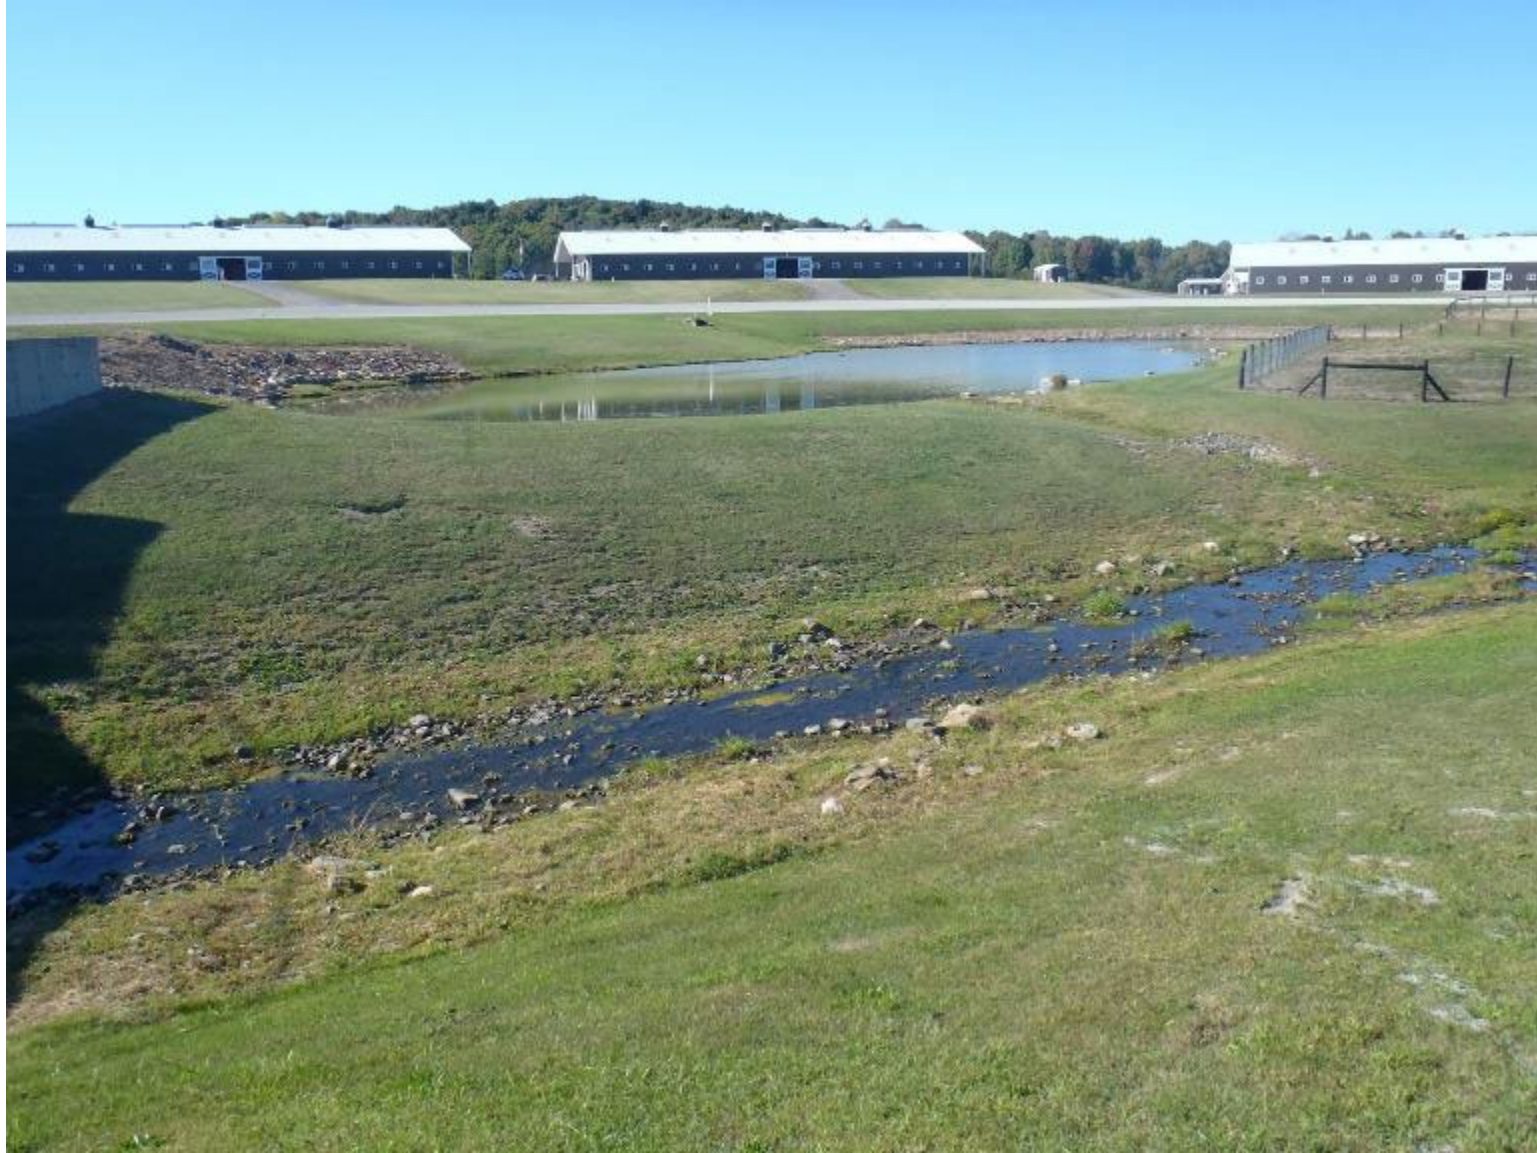
P9220037 – Stream Inside Track, Facing Pond

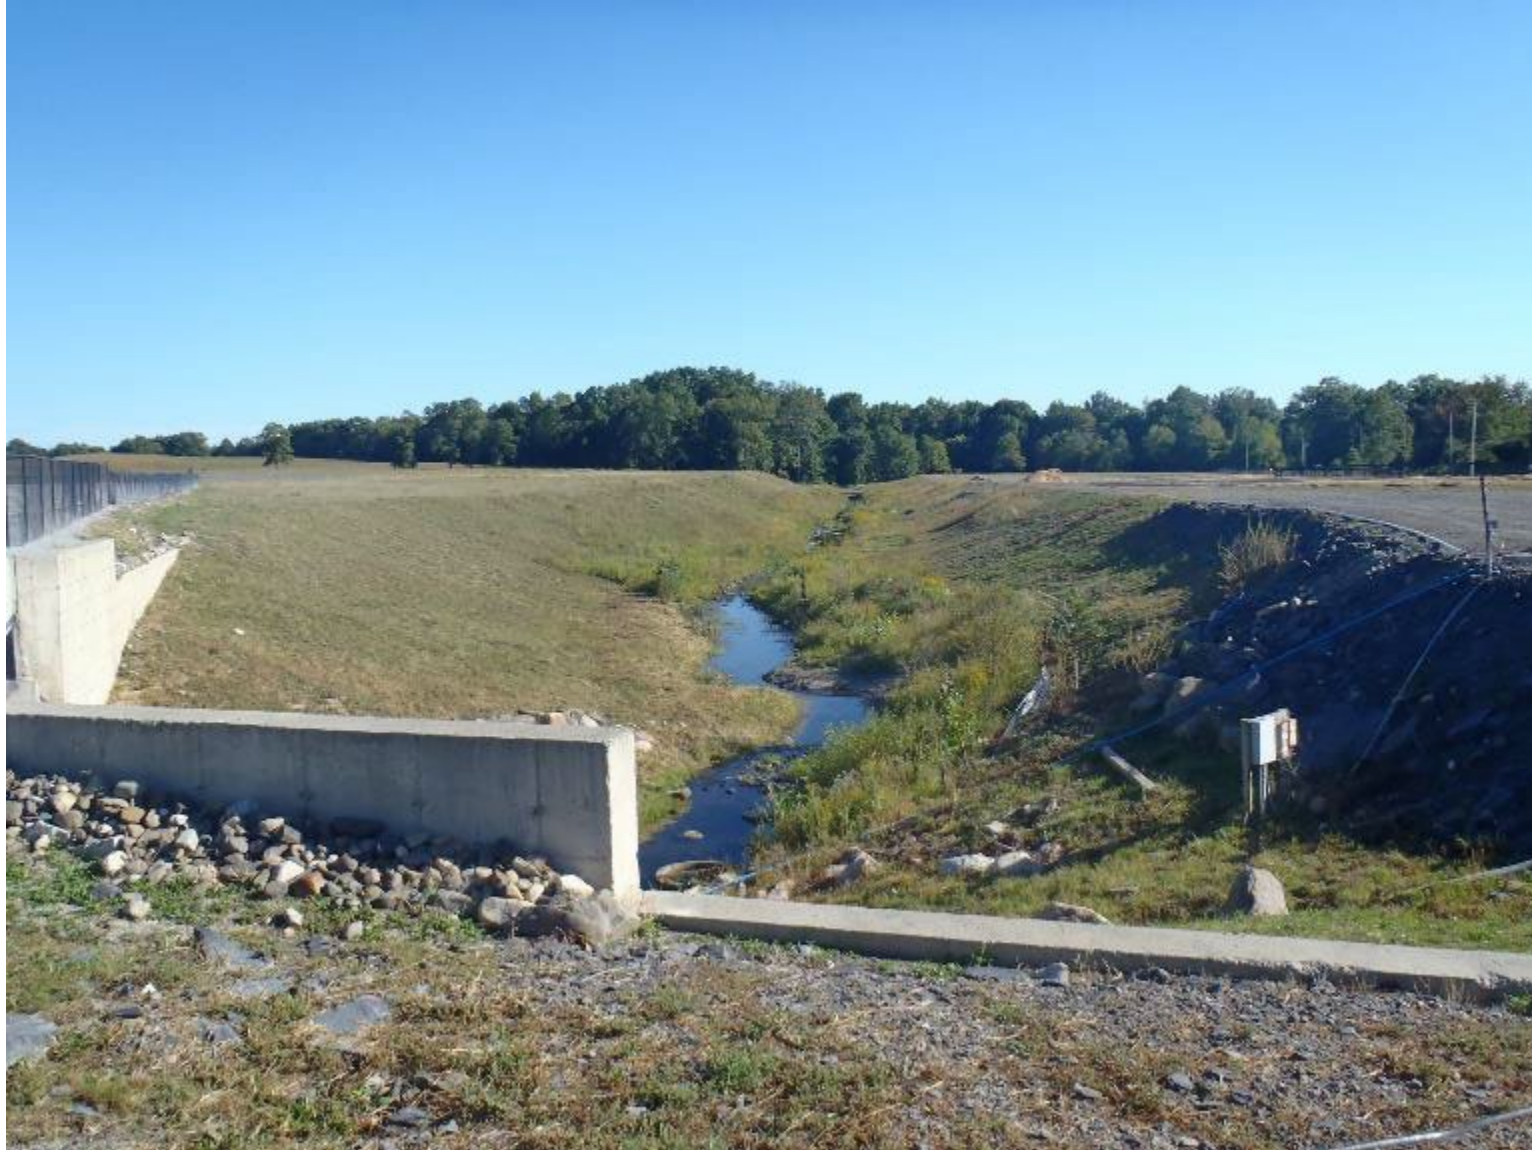
P9220038 – Straightened Stream, Facing Downstream from Outside Edge of Track

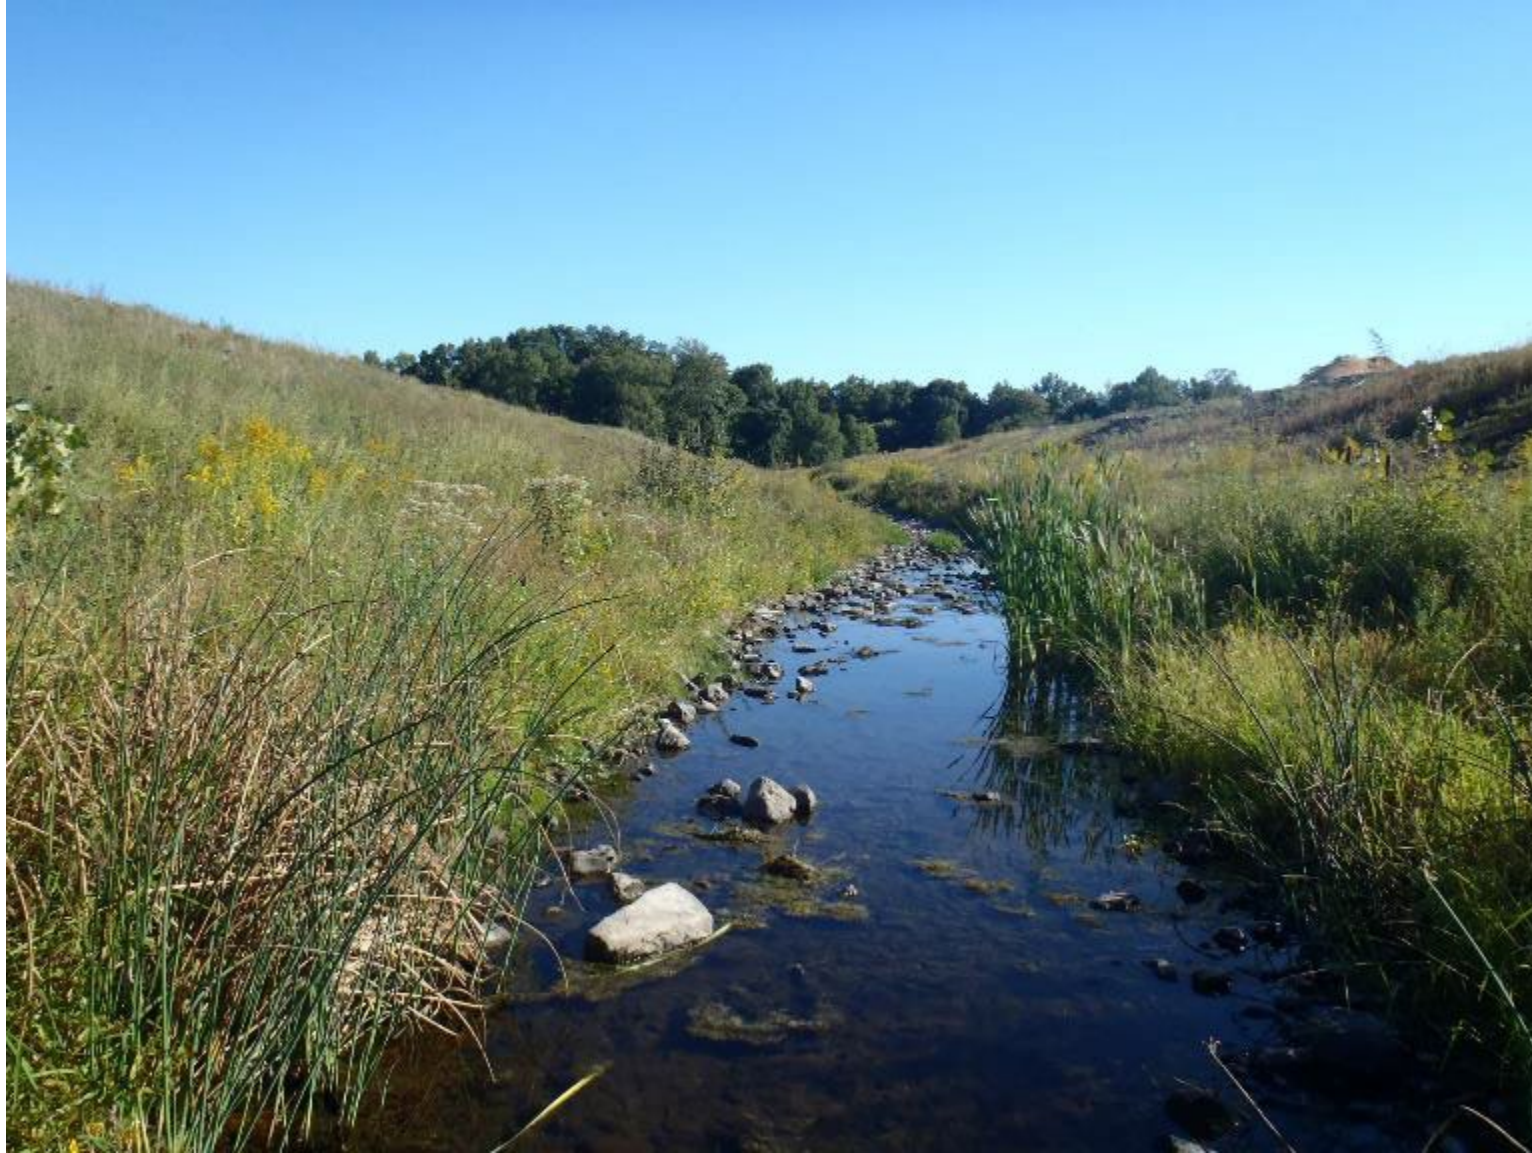
P9220039 – Straightened Stream, Facing Downstream

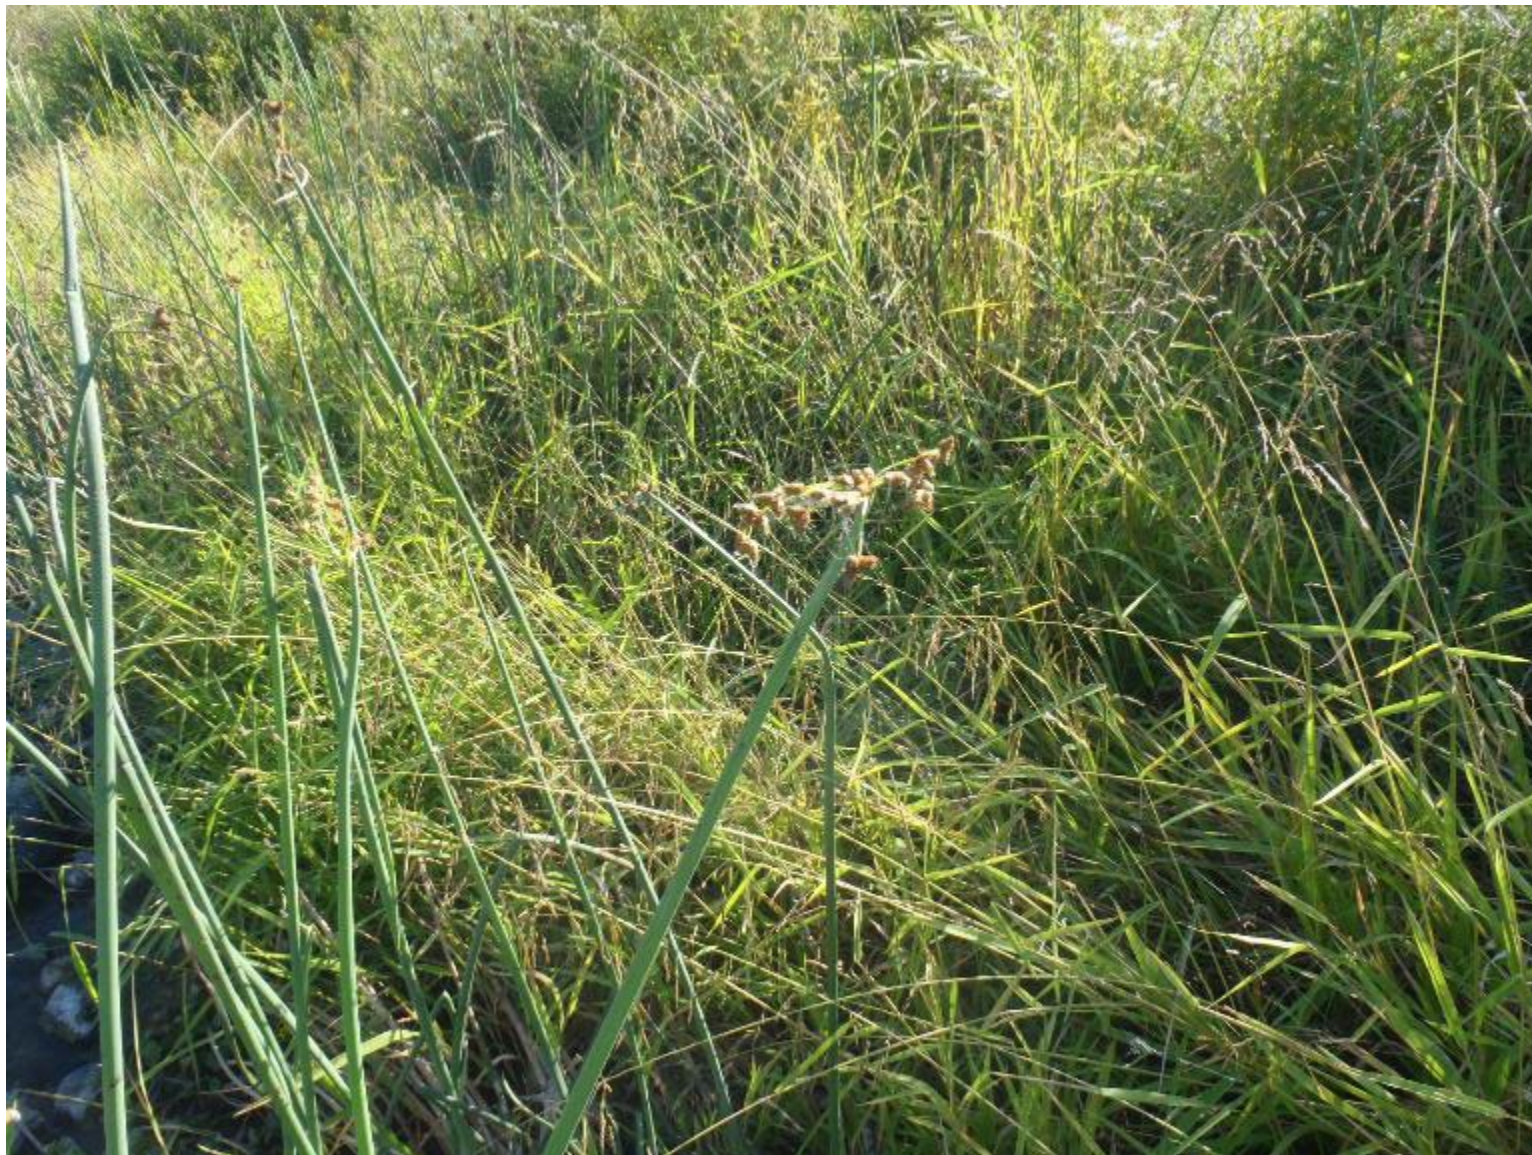
P9220040 – *Schoenoplectus* spp., riparian vegetation along straightened stream

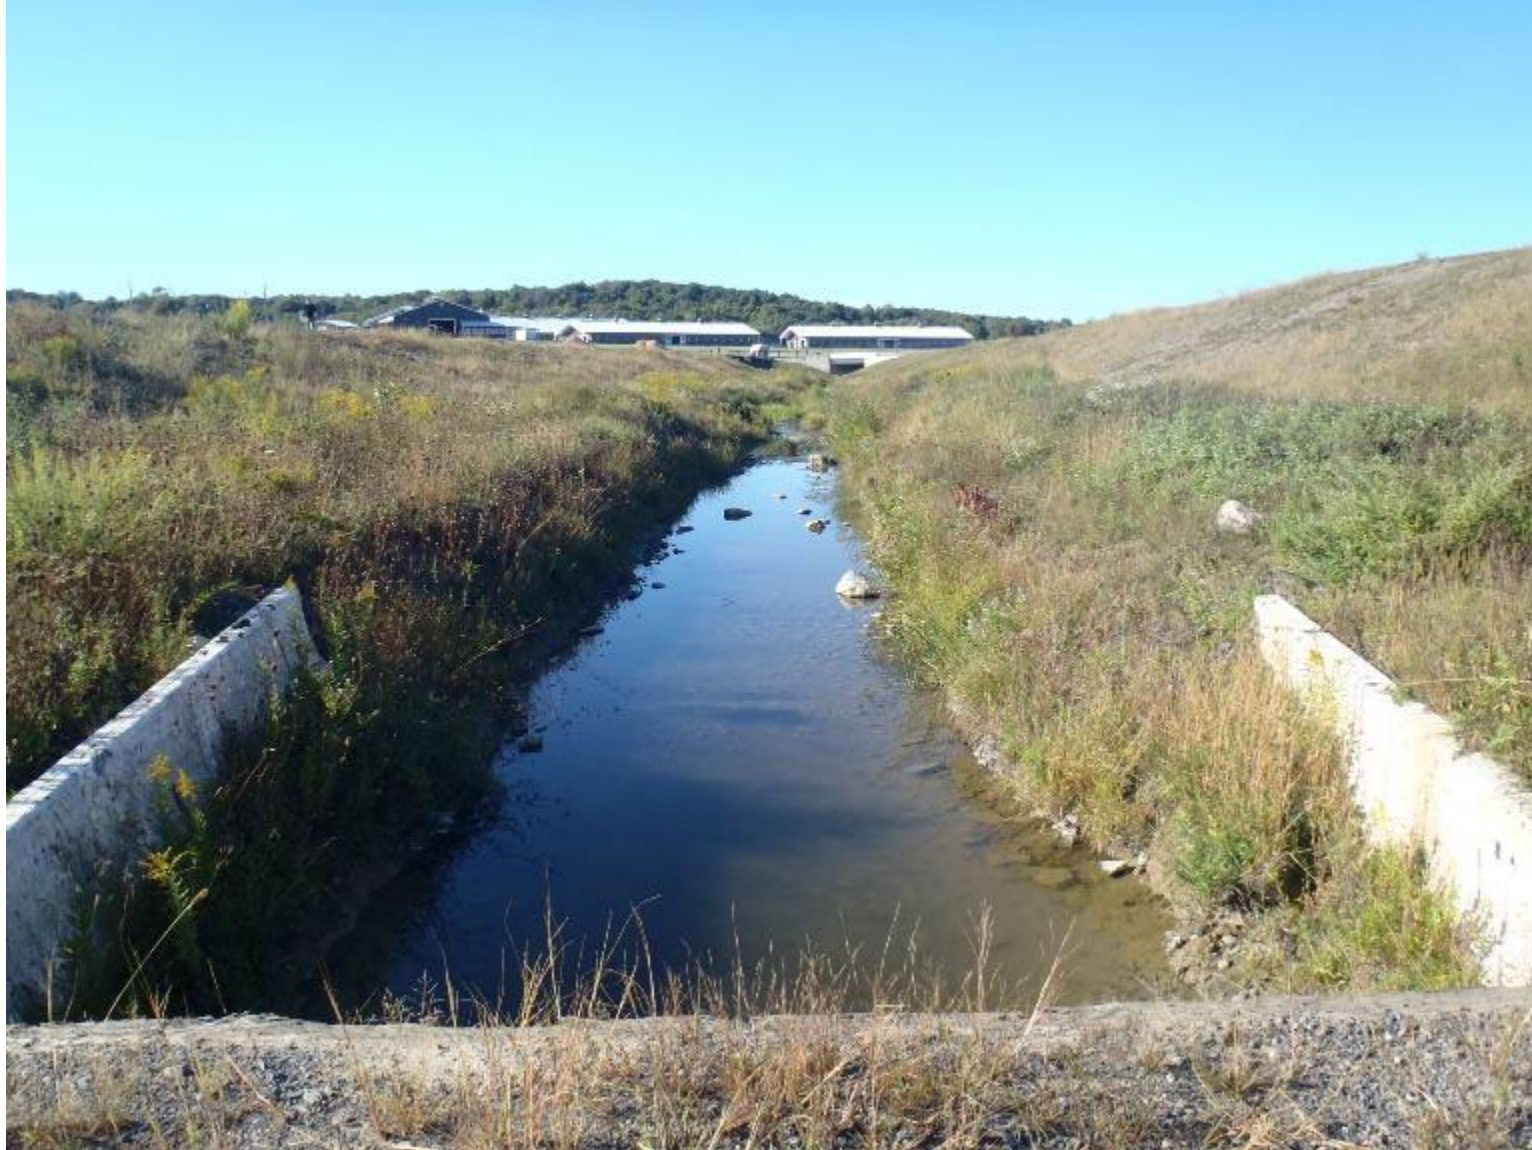
P9220041 – Straightened Stream, Looking Upstream from Small Bridge
